Manhole Inspection Summary

Manhole # S53AA_024MH

Insp Date: **7/16/08 2:19 PM**

Location Address: **3331 mcelderry**

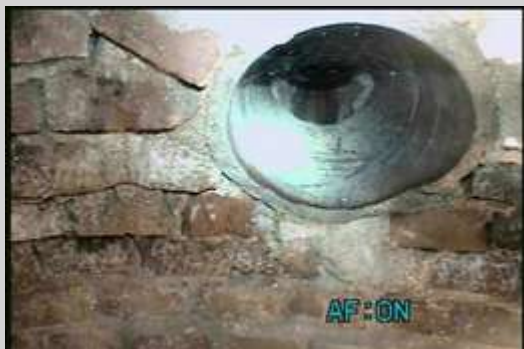
4 O'Clock Inflow

8 in. Circular Gravity Sewer
Pipe In @ 4 O'Clock

Deposits: ☒ None ☐ Mud ☐ Sludge ☐ Debris ☐ Grease

Infiltration: None

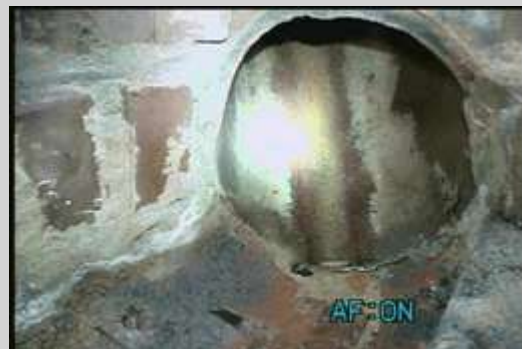
Drop In @ 4 O'Clock

Drop: Outside Direct

Drop Condition: Open
